Road Safety Audit - NE Polk US 27 Mobility Study: US 27 from North of SR 60 to US 192

September 2019

Prepared for: FDOT, District One

Prepared by: AECOM

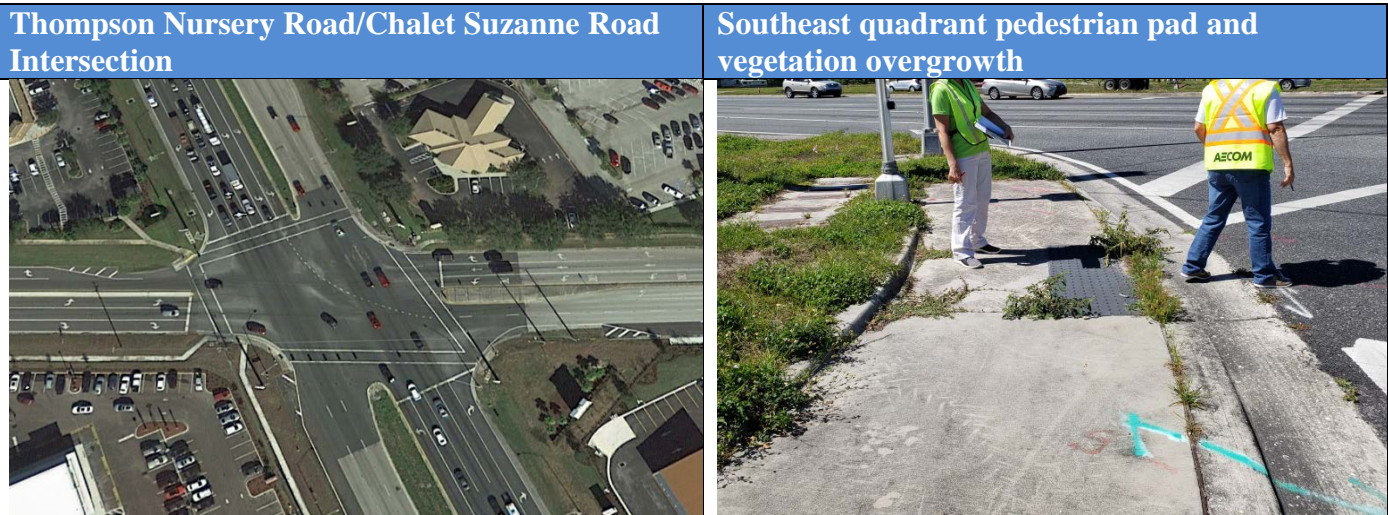
Southeast quadrant sidewalk ends prior to the intersection	Vehicles pull out beyond stop bar to see on-coming traffic to make right turn

Recommendations:
<ul style="list-style-type: none">Install high visibility crosswalks pavement markingsUpdate pedestrian assemblies to current ADA standards with audible push buttons and correct signage and orientationUpdate curb ramps to current ADA standards to include yellow detectable warning padsInstall “Keep Right” signs (MUTCD R4-7) in median concrete traffic separators, as neededImplement leading pedestrian interval with “No Right Turn” LED blank out (MUTCD R3-1)Sidewalk gap fill-in at southeast quadrant (Wawa)Install sidewalk from Hampton Inn & Suites to Thompson Nursery RoadRepair Thompson Nursery Road overhead street designation sign (Coordination with Asset Maintenance work order in progress)Install Stop sign, lighting and pavement markings at Wawa’s entrance/exit (from adjacent properties) for northbound on US 27; remove old parking lot space stripingInstall right turn arrow signal for eastbound with No Right Turn on Red blank out (MUTCD R3-1), due to skewed intersection approachInstall supplemental advance 3-section Left Arrow signal for northbound and southbound left turn lanesReplace supplemental advance 3-section signal with 5-section signal for eastbound and westbound directionsInstall curb and gutters at all four quadrantsInstall additional street lighting on US 27 and Thompson Nursery Road/Chalet Suzanne Road

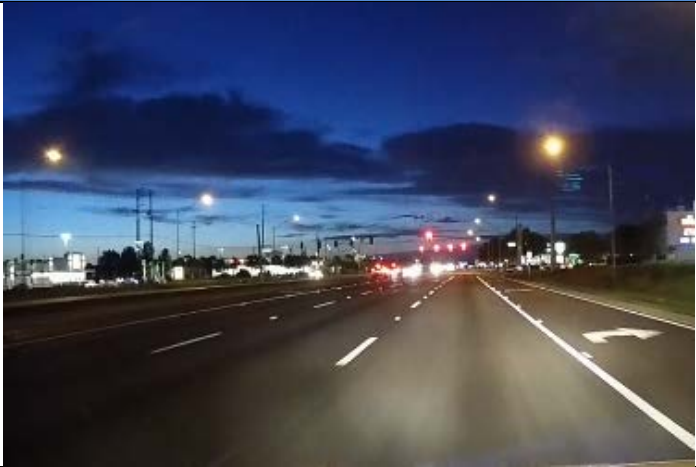
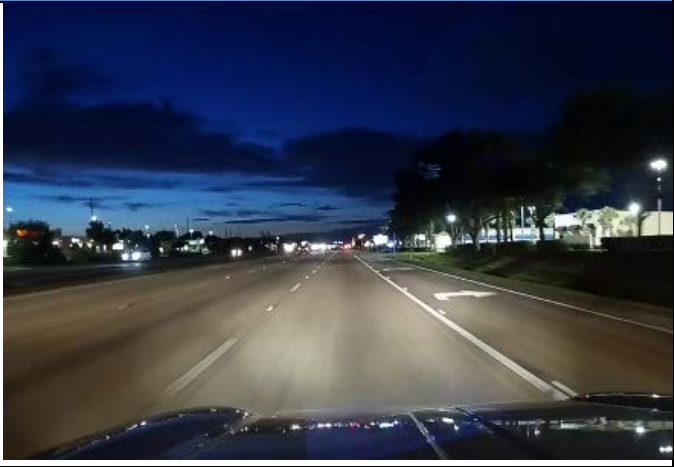
Southbound nighttime lighting, south of intersection	Northbound nighttime lighting, north of the intersection

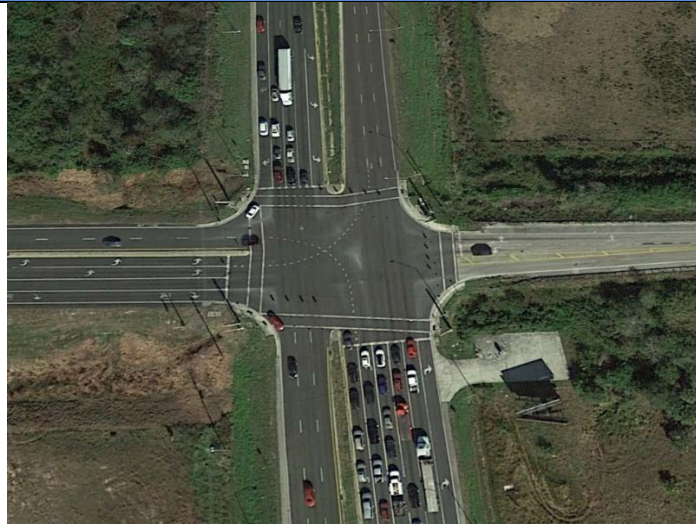
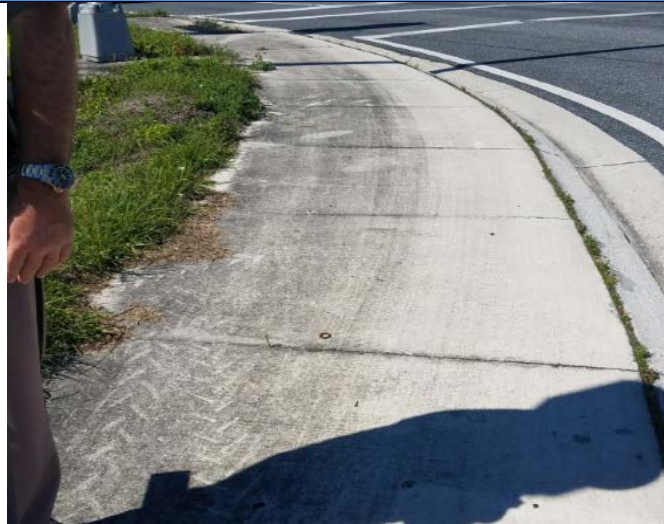
Cypress Gardens Boulevard/Waverly Road Intersection	Southeast quadrant off-tracking

Recommendations:
<ul style="list-style-type: none">Installation of high visibility crosswalksUpdate pedestrian assemblies to current ADA standards with audible, correct signage and orientationUpdate curb ramps to current ADA standards to include yellow detectable warning padsInstall “Keep Right” (MUTCD R4-7) signs as needed in median concrete traffic separatorImplement leading pedestrian intervalInstall “Yield to Pedestrian” (MUTCD R10-15) signsInstall sidewalks from Carlton Arms Apartment to US 27 on the south side of Cypress Gardens BoulevardInstall advance supplement 3-section arrow signal for exclusive left turns for east and west approachesInstall pedestrian handrail at back of sidewalk in southwest andTrim vegetative overgrowthInstall additional street lighting on Cypress Gardens Boulevard/Waverly Road in advance of the intersectionInstall advance supplemental 3-section arrowed signal for exclusive left turns on east and west approaches (Off-system)Repair/install lighted street description sign for Cypress Gardens Boulevard southbound located on concrete poleRepaint pavement markings, as neededRepair rutting street pavement in Northbound center lane on US 27Period cleaning of debris from sidewalks and bike lanes, as needed

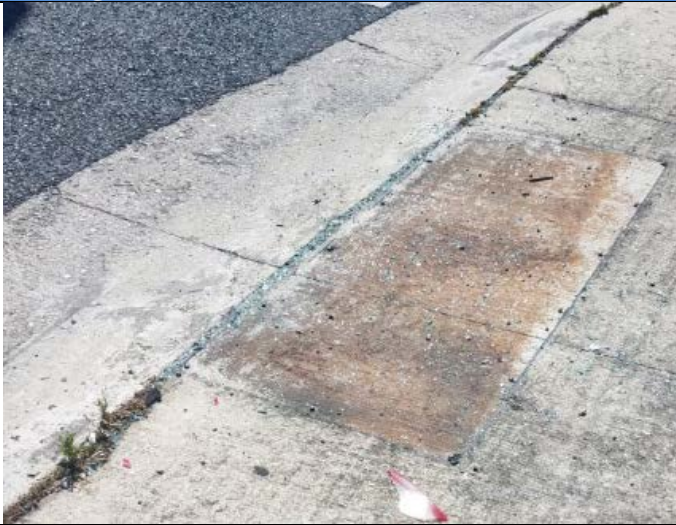
Northwest quadrant warning detector pad missing	Crash marker

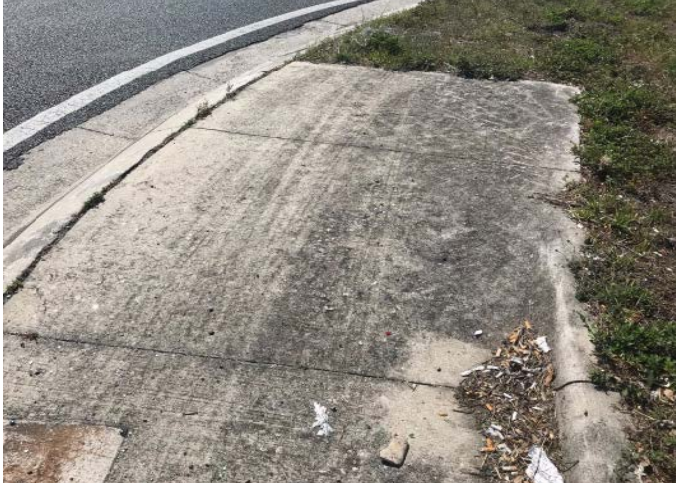
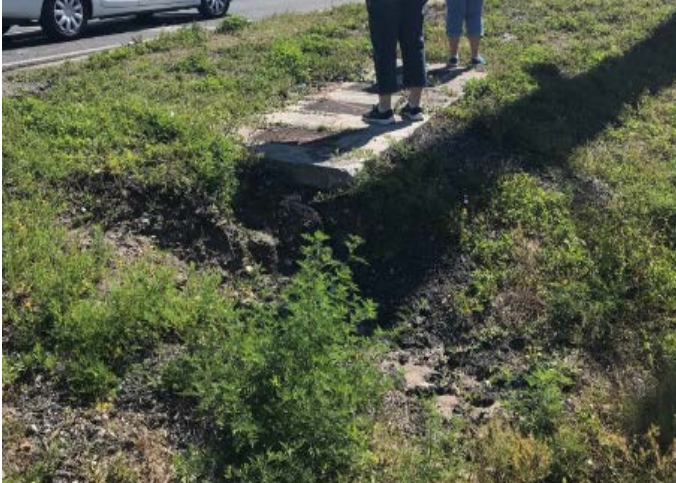
Northwest quadrant off-tracking	Ground erosion

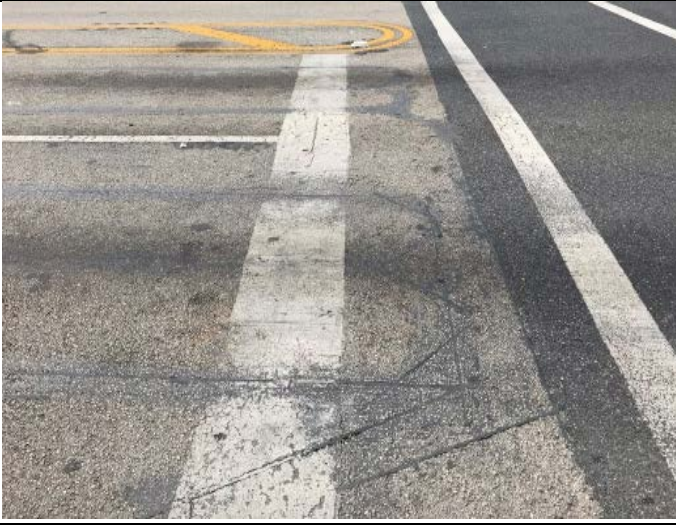
Faded pavement markings	Faded pavement markings

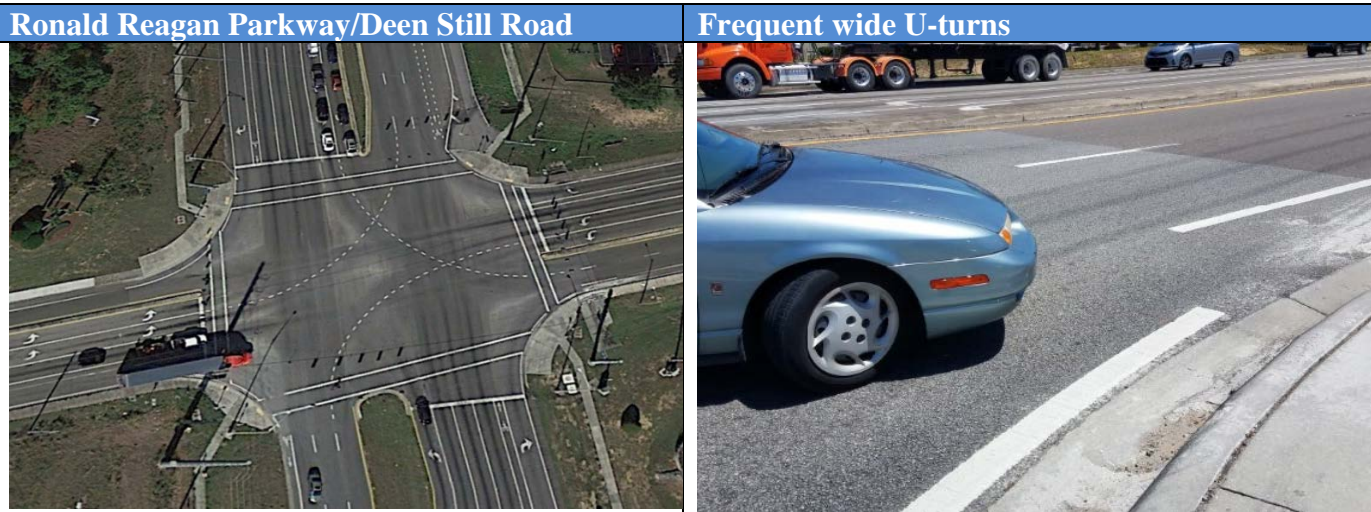
No street lighting on Deen Still Road	No pavement markings for bike key hole lanes on Ronald Reagan Parkway and Deen Still Road	Vegetation overgrowth at drainage grate	Faded pavement markings on Deen Still Road

Southeast quadrant pedestrian warning detector pads missing	Southeast quadrant clogged drain behind sidewalk	Transit bus stop difficult to reach	Offset sidewalk connection to transit

Northeast quadrant Yield to Bikes signage on US 27	Yield to Bikes signage difficult to see from Ronald Reagan Parkway	Sidewalk edge damaged due to ground erosion	Frequent heavy truck right turns from Deen Still Road

Recommendations:
<ul style="list-style-type: none">Install high visibility crosswalksUpdate pedestrian assemblies to current ADA standards with audible push button, correct signage and orientationUpdate curb ramps to current ADA standards to include yellow detectable warning padsInstall “Keep Right” (MUTCD R4-7) signs in median concrete traffic separator, as neededImplement leading pedestrian interval with “Yield to Pedestrian” (MUTCD R10-15) signsInstall street lighting on Deen Still RoadRepair cracked or uneven sidewalks at all four quadrantsInstall right turn arrowed 3-section signal for right turn lanes northbound and southboundInstall “Yield to Pedestrian” signs on east approachInstall advance supplement signs “No Right Turns on Red” for north and east approachesRepaint faded pavement markings crosswalk and stop bar markings for west approachImprovement drainage and ground erosion on northeast and northwest quadrantsRepair transit shelter windowsInstall bike key hole lane pavement markings on Ronald Reagan Parkway and Deen Still RoadRetrofit transit stop connection from sidewalk to shelter, north of intersection heading southboundRepair damaged covers and gratesTrim vegetative overgrowth to help improve stormwater drainageRepair/repaint median traffic separator nose and straighten reflector pole at Ronald Reagan Parkway

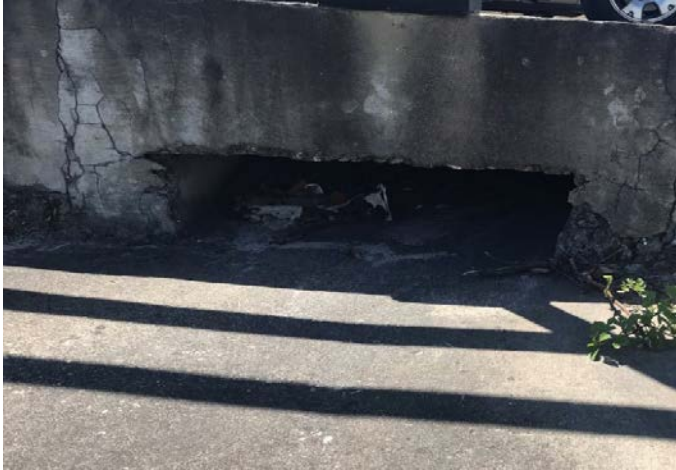
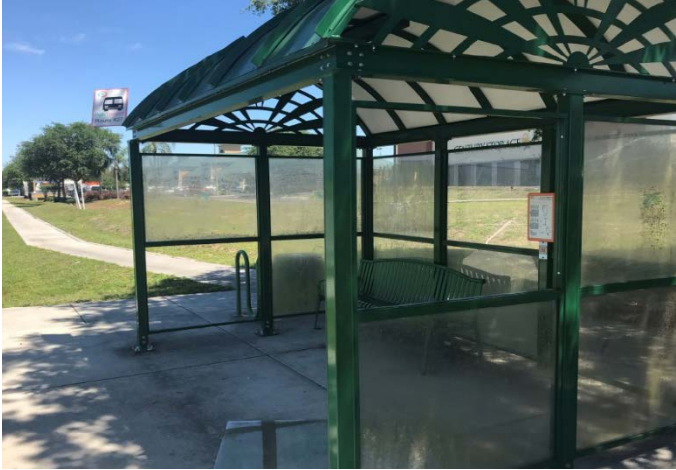
Clogged drainage	Damaged transit facility

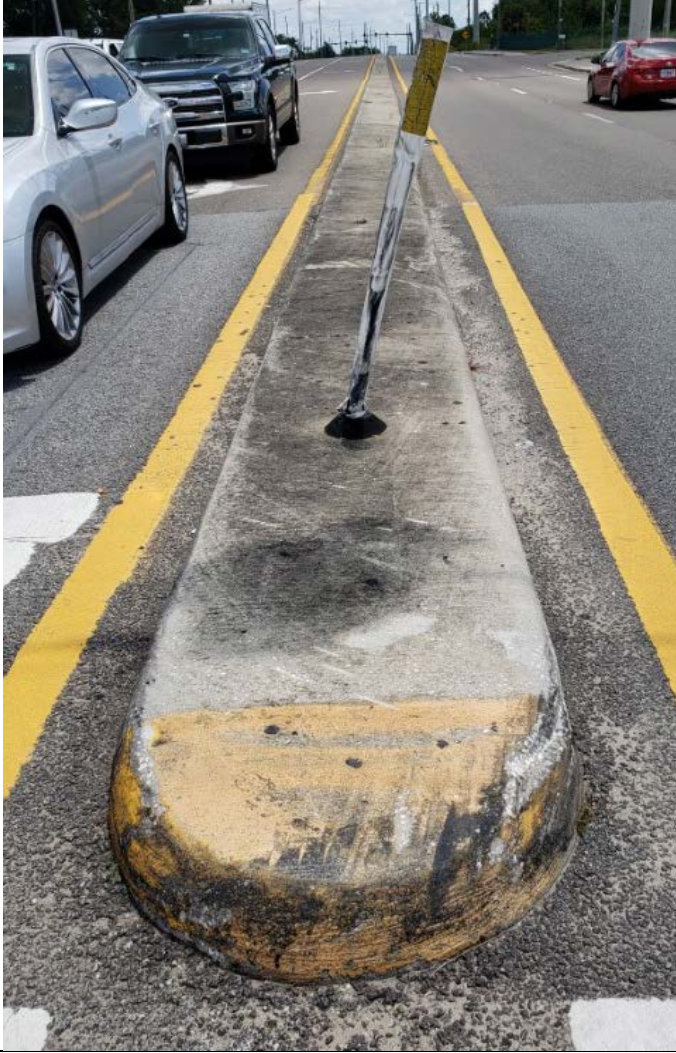
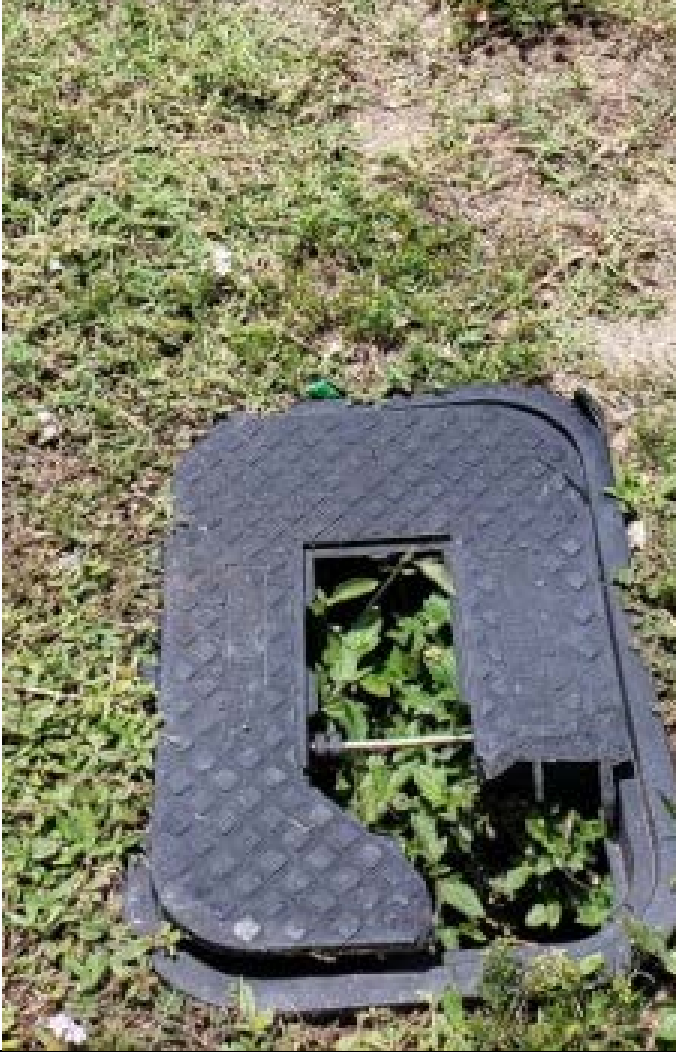
Traffic separator nose is damaged and faded on Ronald Reagan Parkway	Damaged utility box cover

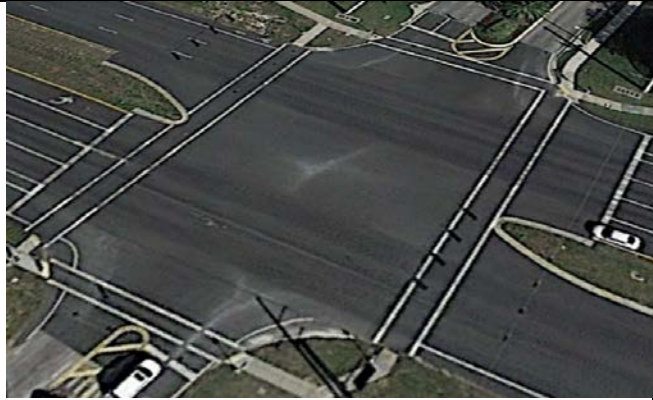
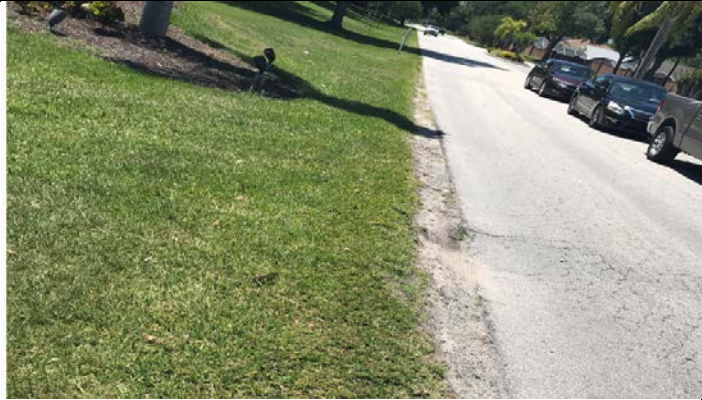
California Boulevard/McFee Drive	Off-tracking on California Boulevard

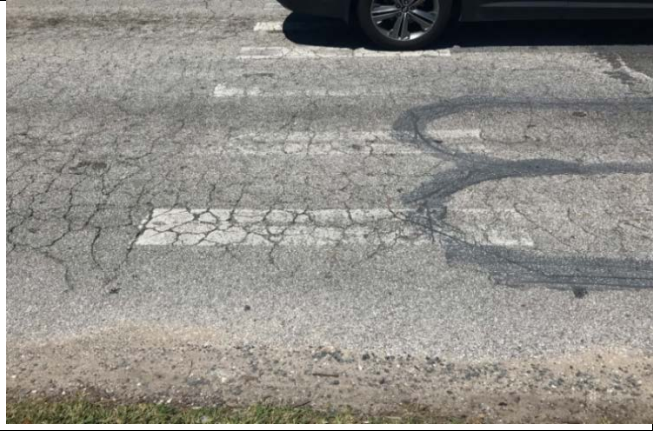
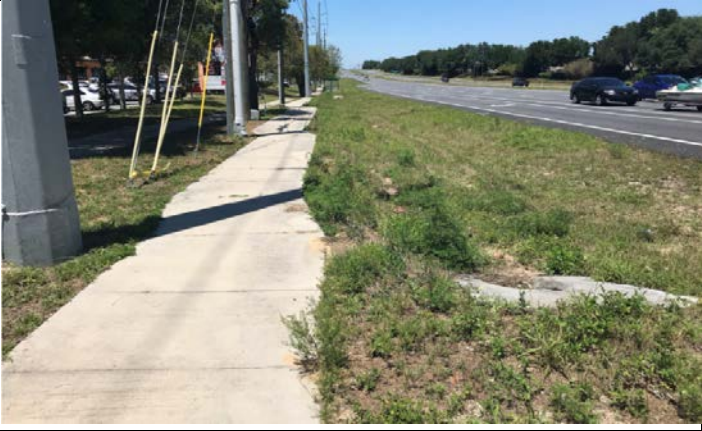
Old faded crosswalk markings still present on California Boulevard	Shoulder slope adjacent to sidewalk

- Remove old crosswalk pavement markings on California Boulevard
- Improve pavement marking for westbound approach to indicate turn designation
- Improve pavement marking for eastbound approach indicating two lanes and lane designation

- Remove landscaping debris
- Repair and level cracked and uneven sidewalks
- Reduce radius for southwest quadrant
- Realign crosswalk for south approach
- Install sidewalk handrail on northwest where shoulder slopes

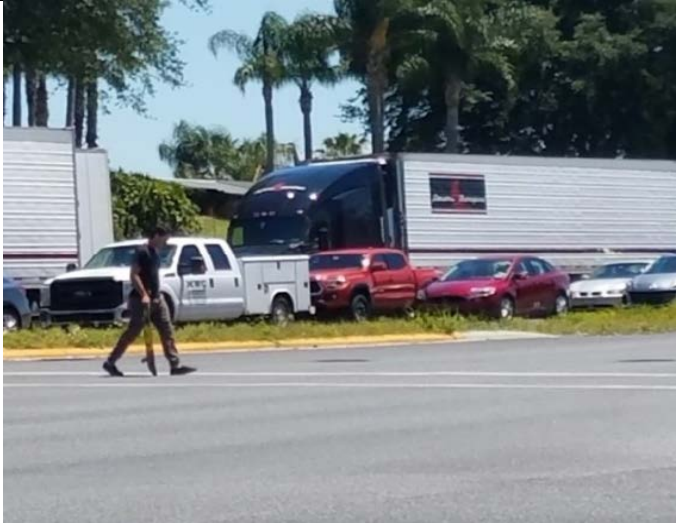
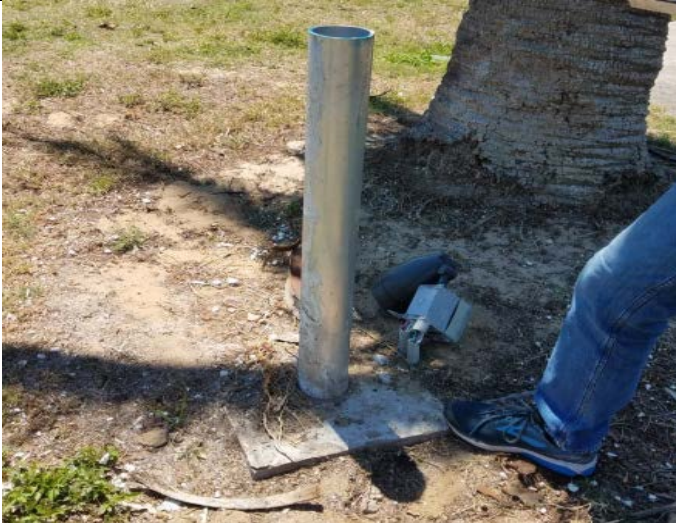
Pedestrian activity	Damaged decorative lighting and aluminum pole

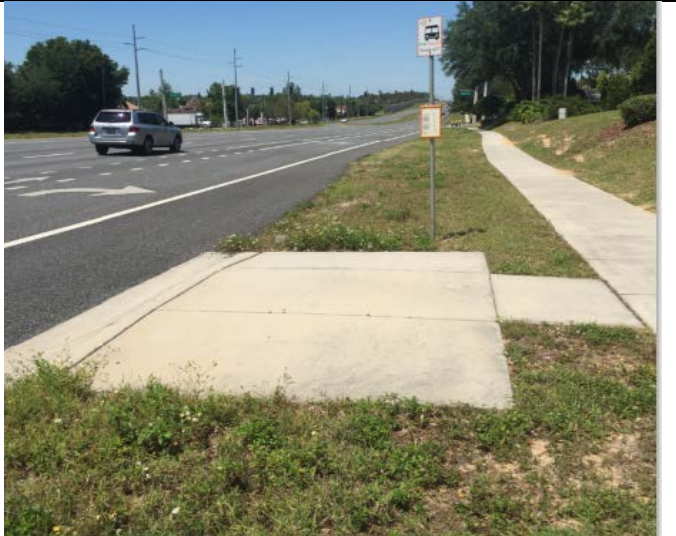
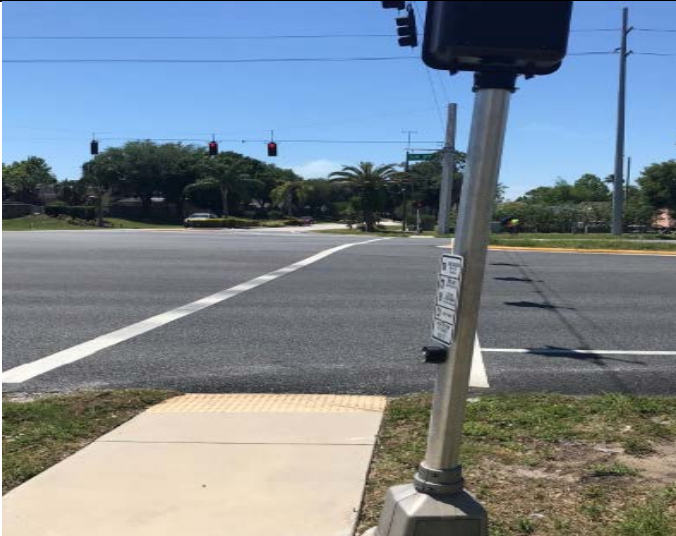
Northbound, no transit amenities, north of intersection	Pedestrian signal pole tilted

- Implement leading pedestrian interval with “Yield to Pedestrian” (MUTCD R10-15) signs
- Update/repair transit stops with pads and shelter/bench amenities

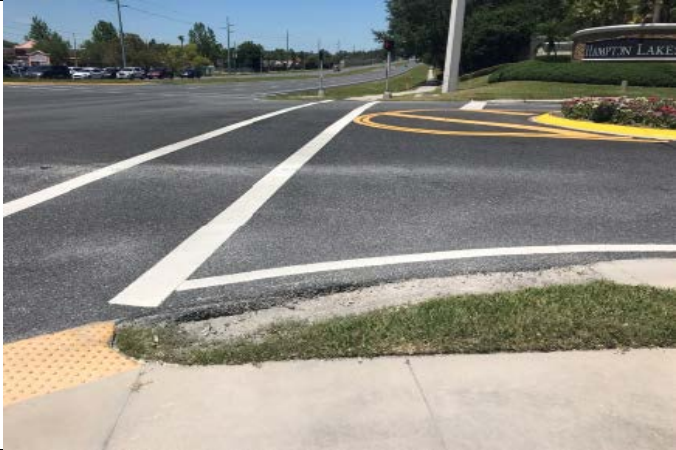
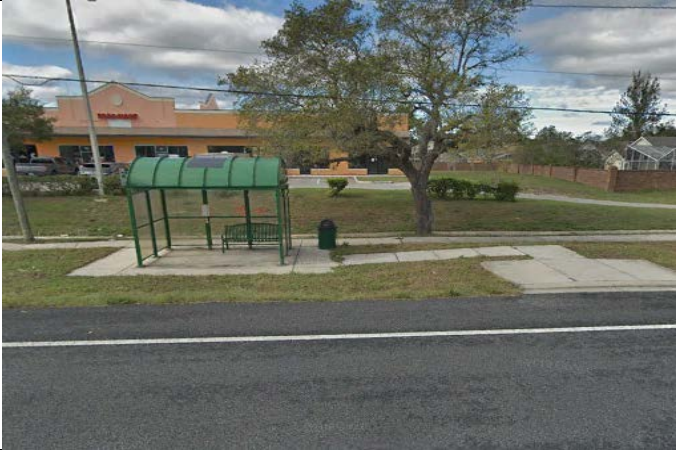
Off-tracking on McFee Drive	Southbound, transit shelter

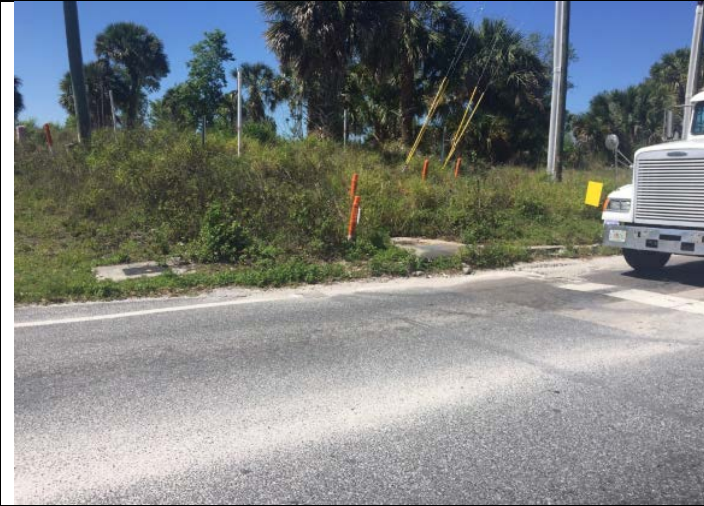
Western side drainage issue (Off-system)

- Install “No Right Turn on Red” LED (MUTCD R3-1) w 5-section head signal for westbound to northbound; also, consider for eastbound to southbound due to sidestreet heavy trucks observed turning on red without stopping
- Improve drainage run-off and erosion
- Install curb and gutter at all four corners
- Connect transit stop shelter to inside sidewalk south of the intersection
- Improve sidewalks connections to and from Sand Mine Road
- Periodic law enforcement to monitor speeding through the intersection
- Install street lighting at intersection and approaches

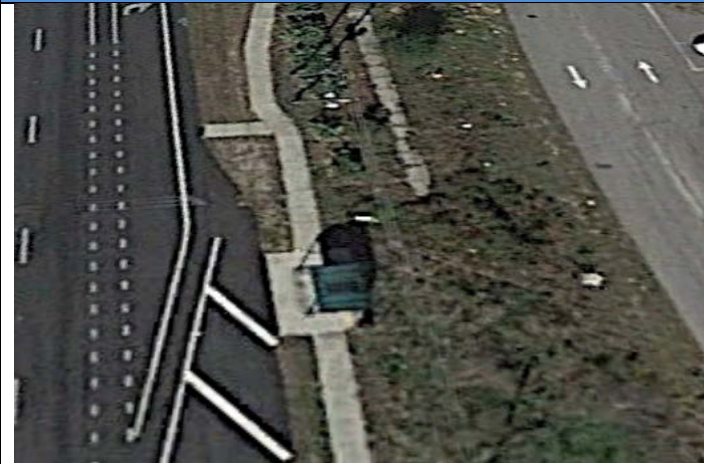
Southeast dual sidewalks no connection to transit shelter

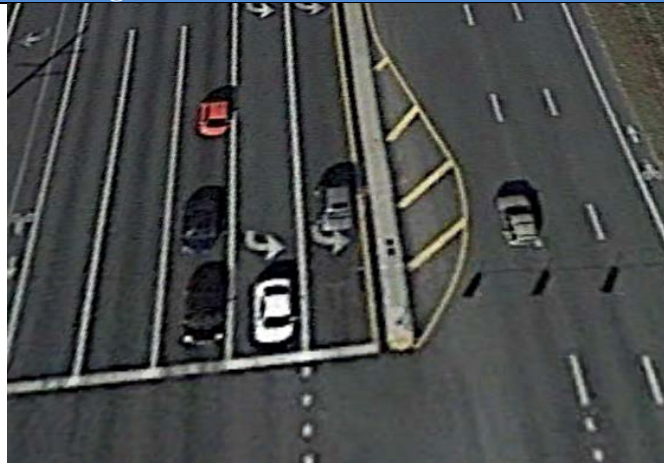
Left turn storage lane painted pavement markings

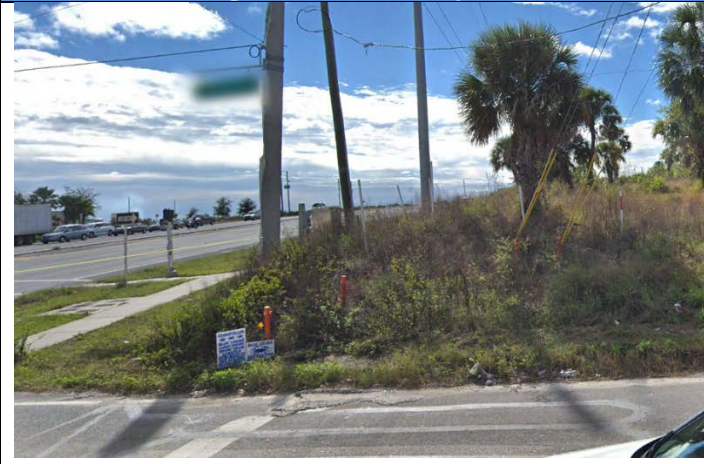
Southwest corner no sidewalk on Sand Mine Road connecting to US 27 (Off-system)

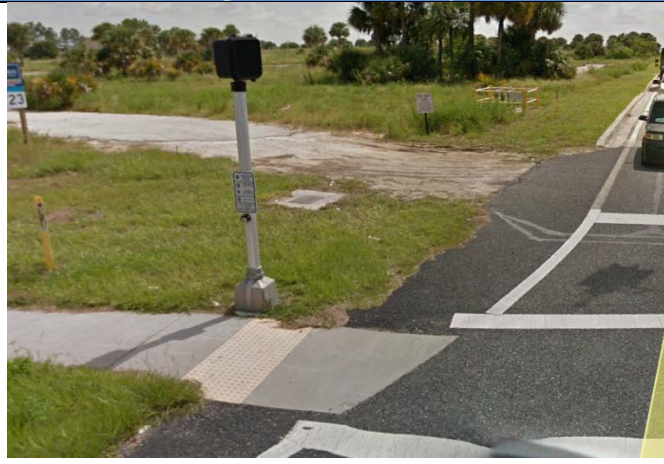
Northeast corner no sidewalk on Sand Mine Road connecting to US 27 (Off-system)

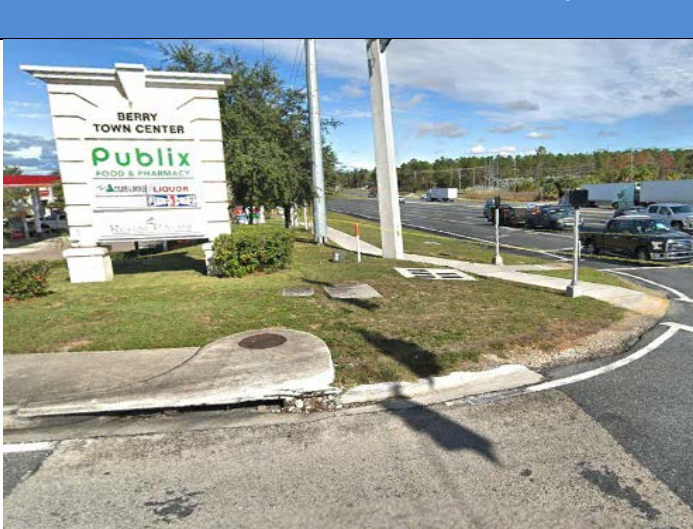
Northwest corner sidewalks disconnected between Sand Mine Road to US 27 (Off-system)

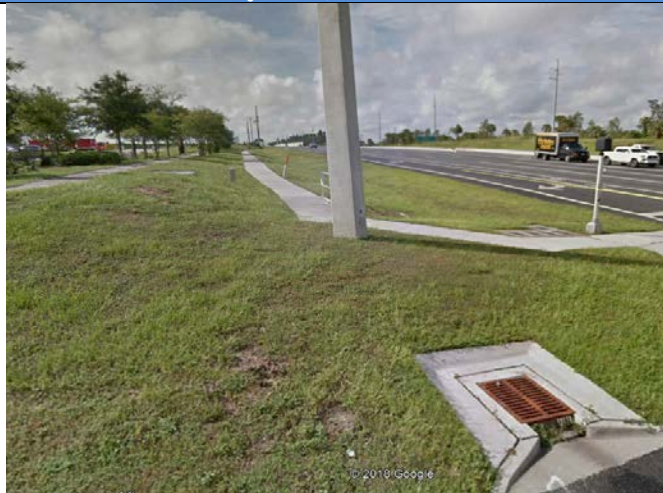
Southeast corner sidewalks disconnected between dual sidewalks. No sidewalk on Sand Mine Road (Off-system)

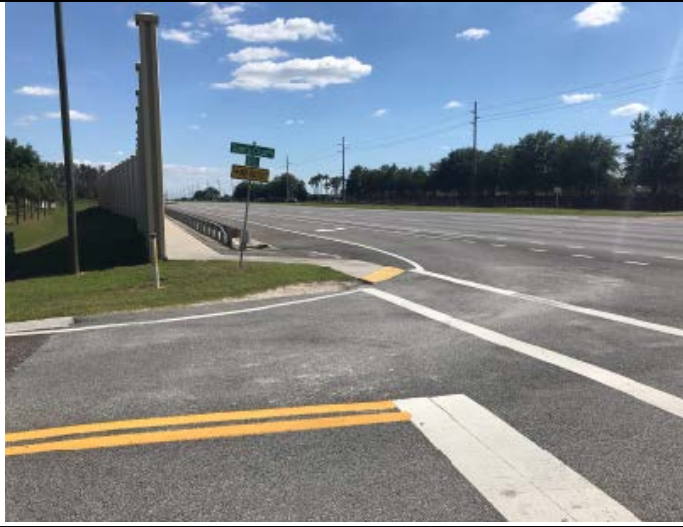
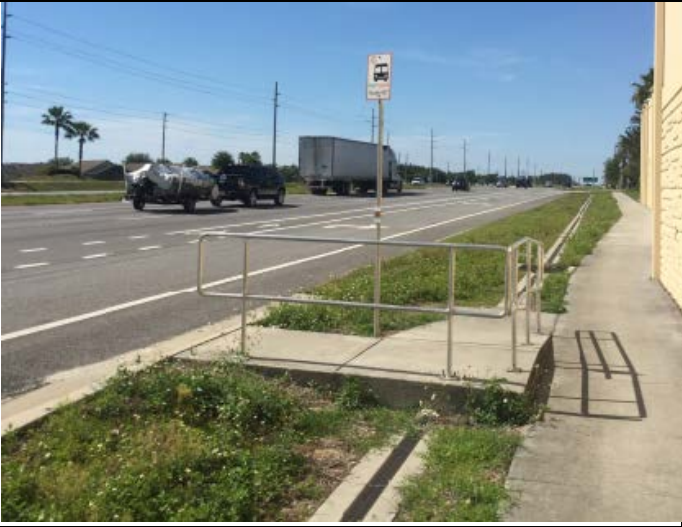
Elgin Boulevard/Santa Cruz Drive	
No lighting on US 27	Northeast transit stop, no shelter

<ul style="list-style-type: none">Minor off-tracking in northwest and southwest quadrants
Recommendations:
<ul style="list-style-type: none">Along US 27 from Ronald Reagan Parkway/Deen Still Road to California Boulevard/McFee Drive, as needed<ul style="list-style-type: none">Improve sidewalks including handrails where there is significant sloping of drainage and fill-in gaps to provide continuous sidewalks and connection to sidestreetsInstall additional street lighting on both sides of US 27Update transit stops with pads and shelter/bench amenitiesDetermine school crossing locations and update with school signsPeriodic cleaning of sidewalk and bike laneConduct pedestrian crossing visibility studyConduct sight distance studyConduct spot speed studyUnsignalized intersection #1 – Central Grove Road/Terra Del Sol Boulevard<ul style="list-style-type: none">Convert to bi-directional median openingInstall high visibility crosswalks at signalized intersection as well as sidestreet crosswalksRepair/retrofit curb radius to eliminate rutting/off-tracking damageUpdate curb ramps to current ADA standards to include yellow detectable warning padsRepair/replace damaged signageRepaint pavement markings, as neededSignalized intersection #2 – Four Corners Boulevard/Bella Citta Boulevard<ul style="list-style-type: none">Repair/replace/update pedestrian assemblies to current ADA standards with audible push button, correct signage and orientation at signalized intersection as well as sidestreet crosswalksRepair/retrofit curb radius to eliminate rutting/off-tracking damageUpdate curb ramps to current ADA standards to include yellow detectable warning padsInstall “Keep Right” (MUTCD R4-7) signs in median concrete traffic separator, as neededImplement leading pedestrian interval with “Yield to Pedestrian” (MUTCD R10-15) signsInstall handrails adjacent to sidewalk in southwest quadrantInstall raised islands at locations with exclusive right turnsConnect sidewalk from northside of Four Corners Boulevard to westside of US 27, significant elevation differenceConsider split phase signal due to permissive left turn/aggressive driversUnsignalized intersection #3 – Elgin Boulevard/Santa Cruz Lane<ul style="list-style-type: none">At full median opening provide additional signage and (MUTCD R1-1 or R1-2, R6-1 and R6-3) and delineate the median area with pavement stripingRepair/retrofit curb radius to eliminate rutting/off-tracking damageInstall high visibility crosswalks at signalized intersection as well as sidestreet crosswalksUpdate curb ramps to current ADA standards to include yellow detectable warning padsRepair/replace damaged signageRepaint pavement markings, as neededUnsignalized intersection #4 – Oglethorpe Road<ul style="list-style-type: none">At full median opening provide additional signage and (MUTCD R1-1 or R1-2, R6-1 and R6-3) and delineate the median area with pavement stripingRepair/retrofit curb radius to eliminate rutting/off-tracking damageInstall high visibility crosswalks at signalized intersection as well as sidestreet crosswalksUpdate curb ramps to current ADA standards to include yellow detectable warning padsRepair/replace damaged signageRepaint pavement markings, as needed

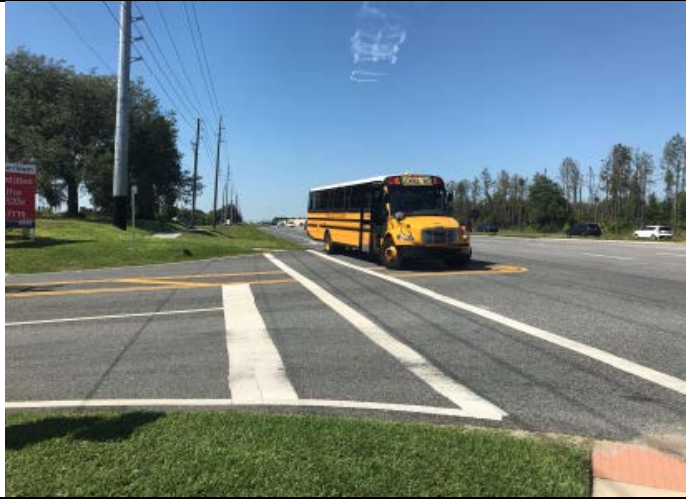
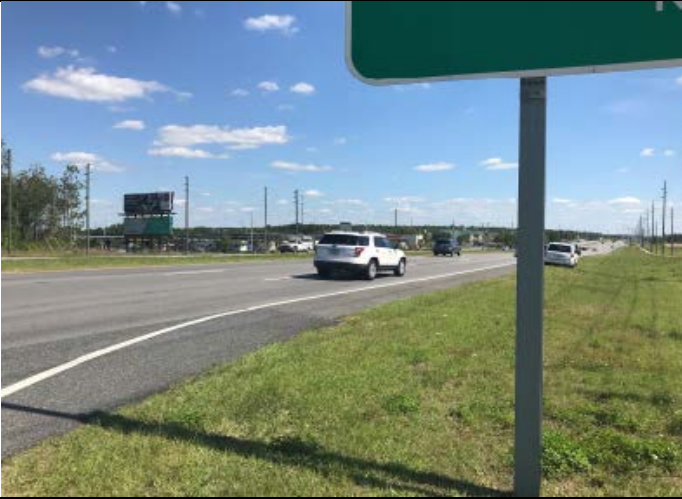
School bus stop location	Northbound to southbound U-turns
