Road Safety Audit - NE Polk US 27 Mobility Study: US 27 from North of SR 60 to US 192

September 2019

Prepared for: FDOT, District One

Prepared by: AECOM

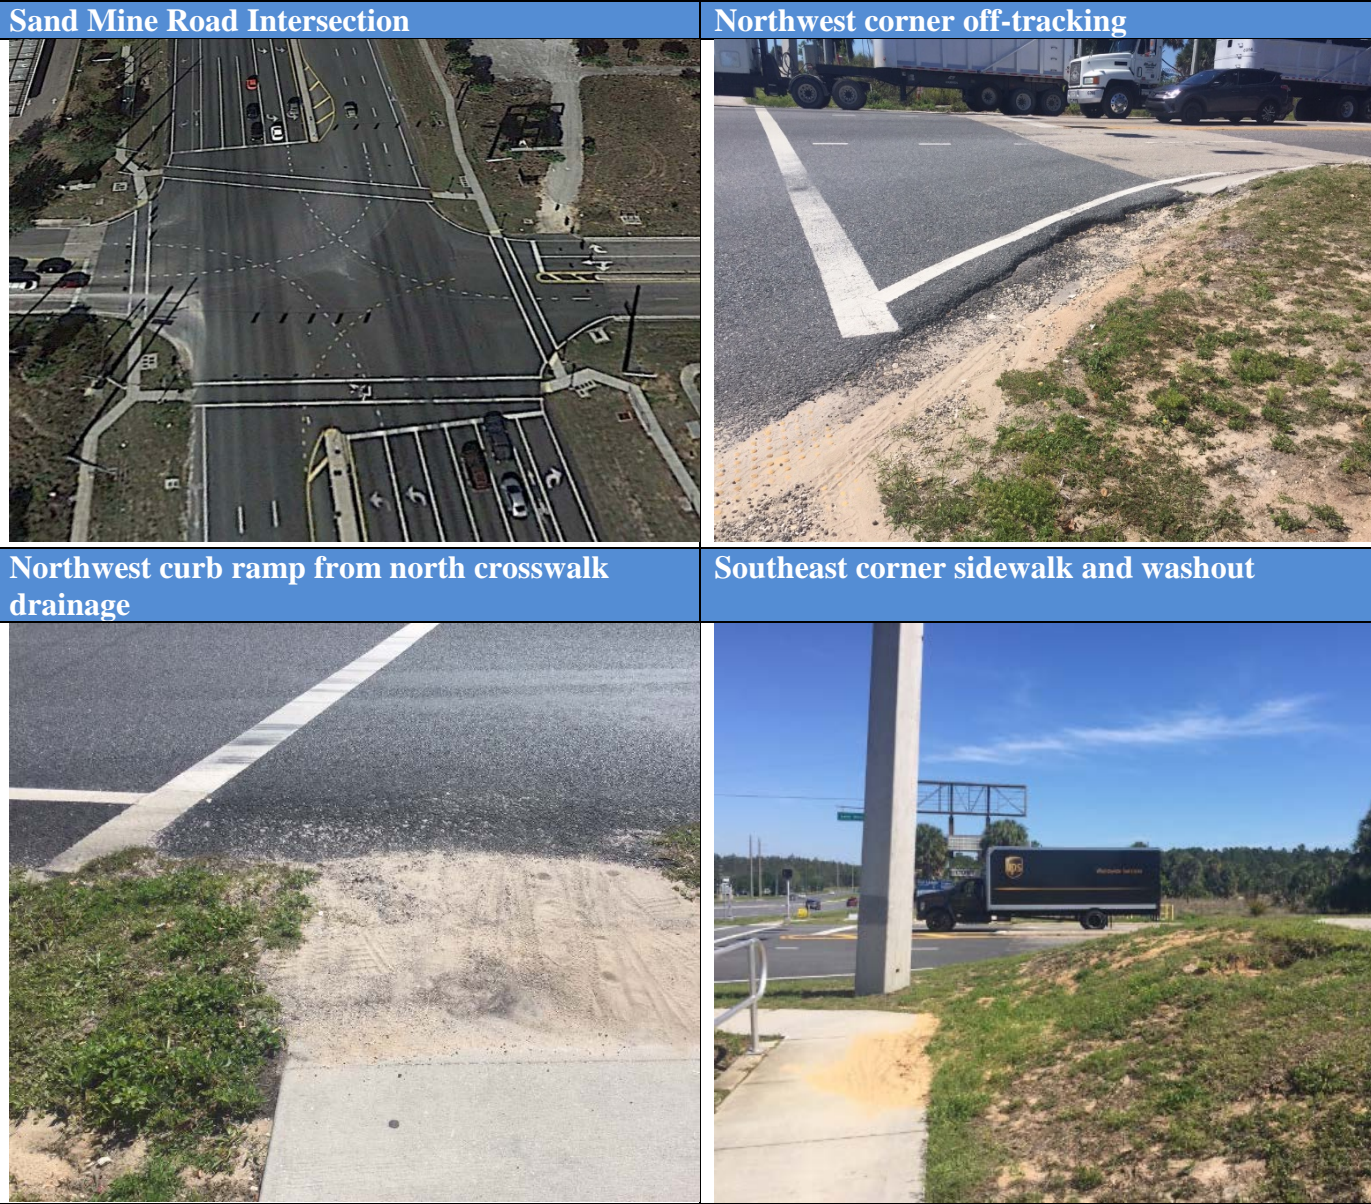
Western side drainage issue (Off-system)

- Install “No Right Turn on Red” LED (MUTCD R3-1) w 5-section head signal for westbound to northbound; also, consider for eastbound to southbound due to sidestreet heavy trucks observed turning on red without stopping
- Improve drainage run-off and erosion
- Install curb and gutter at all four corners
- Connect transit stop shelter to inside sidewalk south of the intersection
- Improve sidewalks connections to and from Sand Mine Road
- Periodic law enforcement to monitor speeding through the intersection
- Install street lighting at intersection and approaches
